AN OASIS FOR RAILROADERS IN THE MOJAVE
The History and Architecture of the Los Angeles and Salt Lake Railroad Depot,
Restaurant and Employees' Hotel at Kelso, California, on the Union Pacific System

Kelso Depot Historic Structure Report

National Preserve • California

January 1998

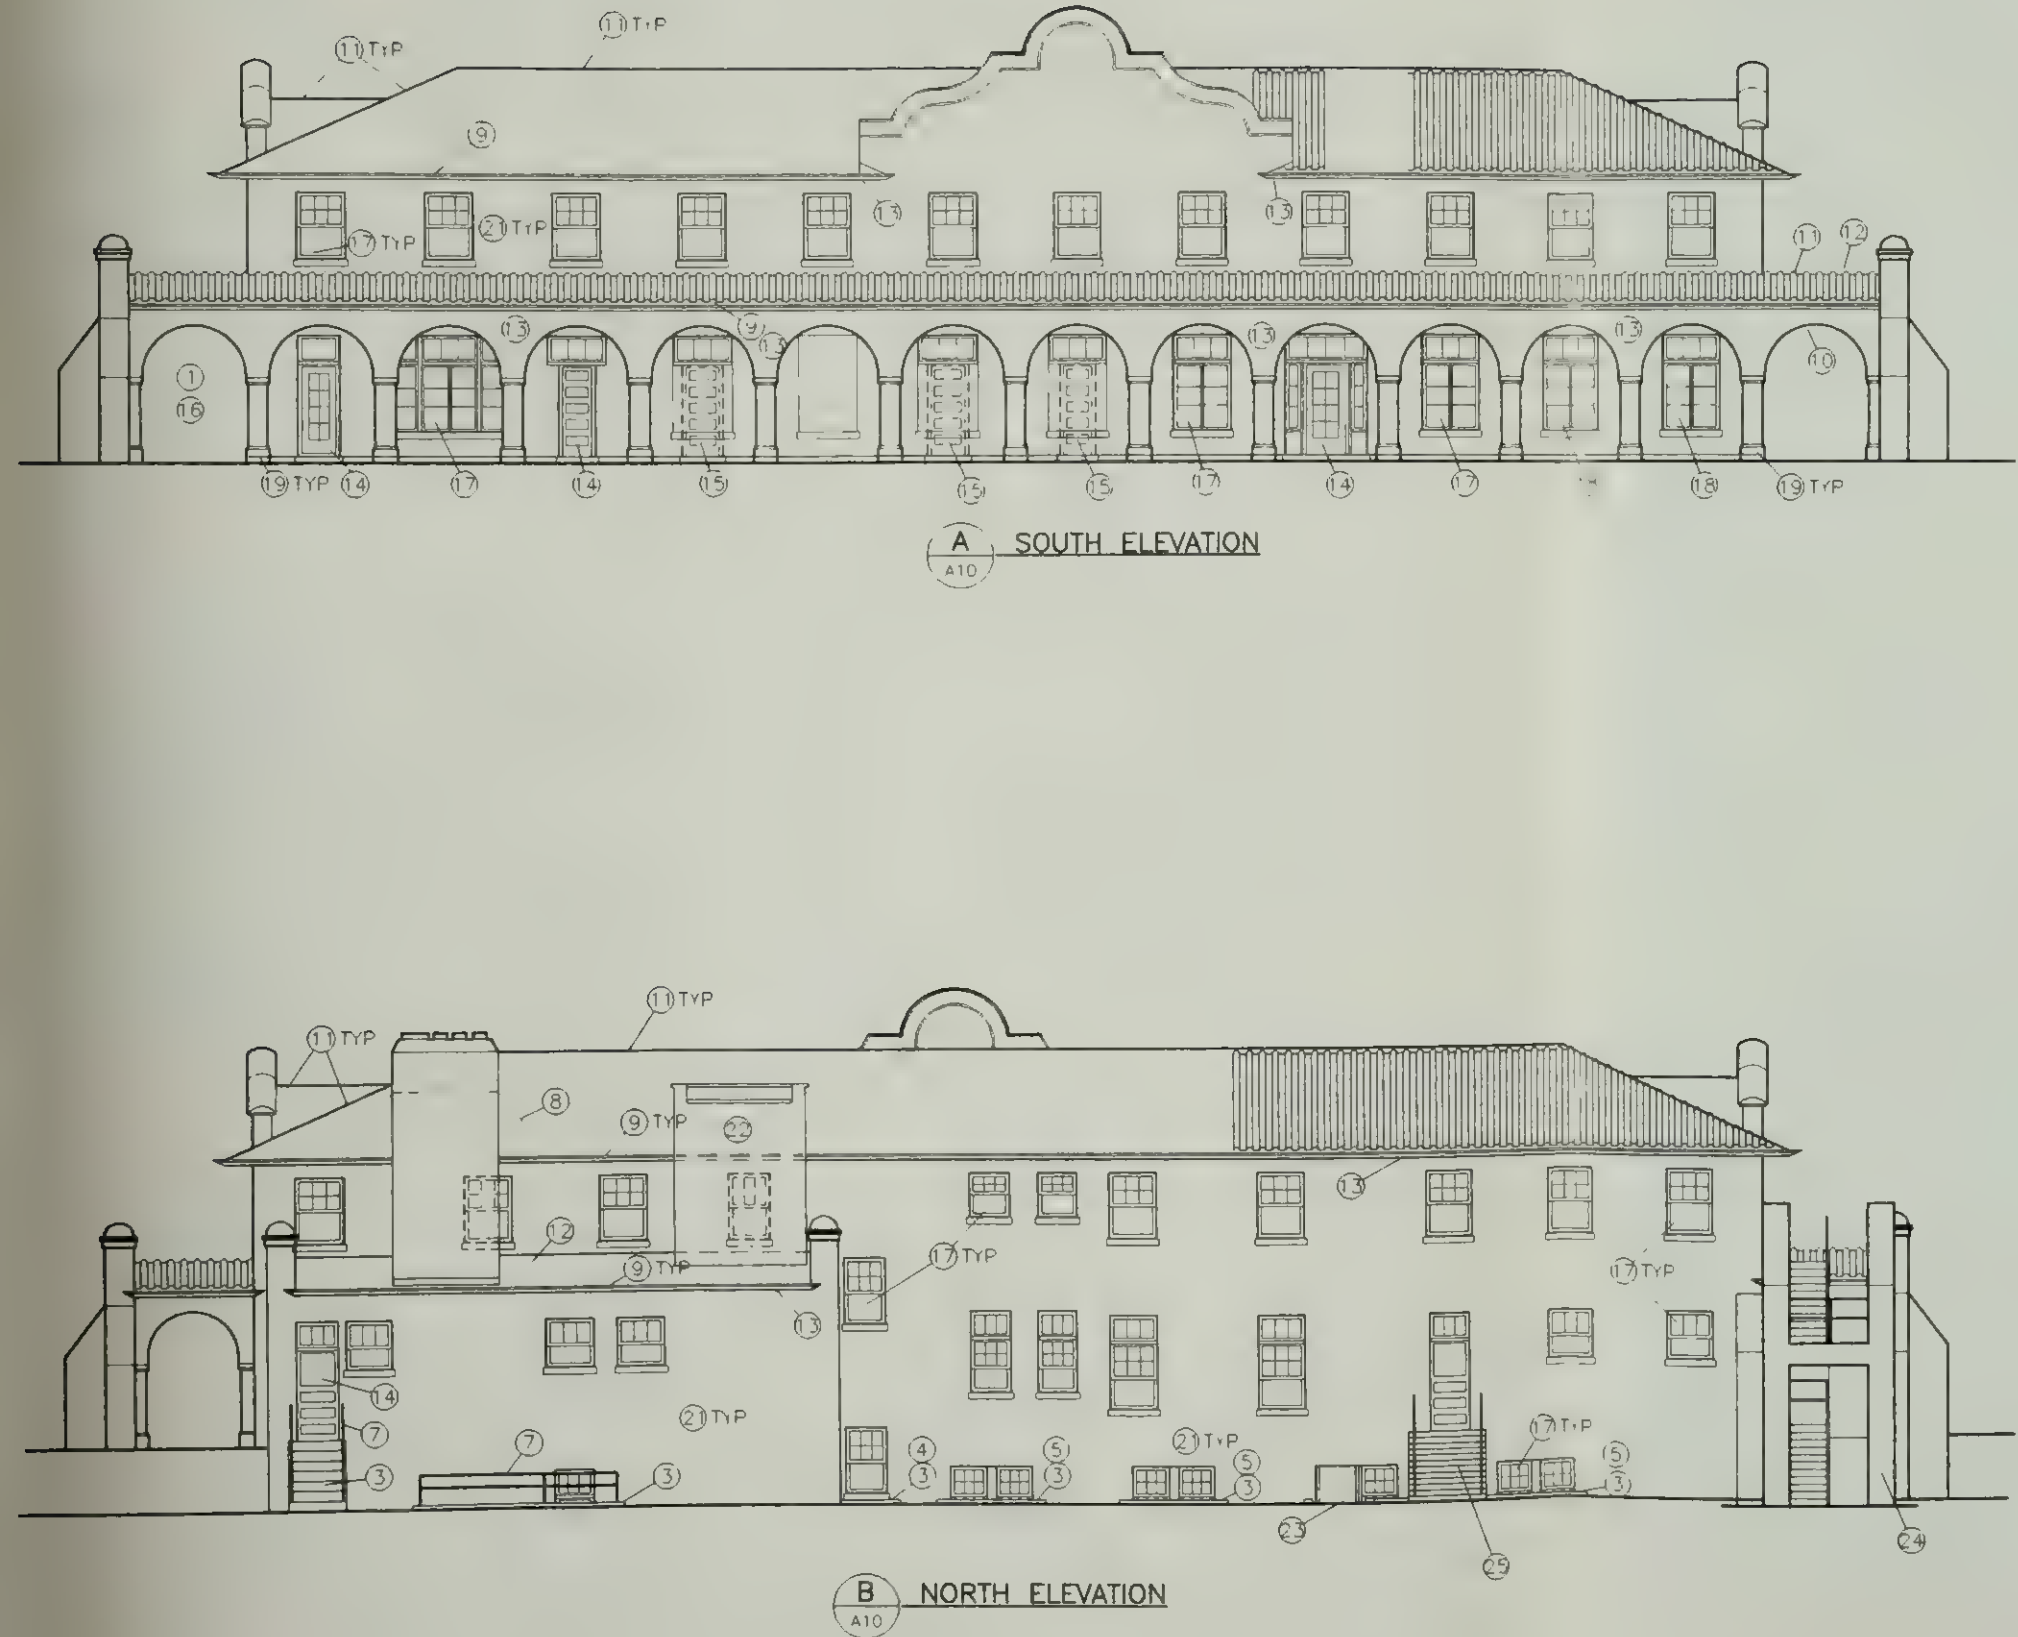
Drawing 25: Kelso Depot Rehabilitation, North and South Elevations, No. 170/25,000, Sheet 11 of 12, September 1997, NPS.

- (22) NEW ELEVATOR SHAFT
(23) NEW BASEMENT EGRESS
(24) NEW ALTERNATIVE 1 EXTERIOR EGRESS STAIR
(25) NEW ALTERNATIVE 2 EGRESS STAIR (WITH INTERIOR STAIR)

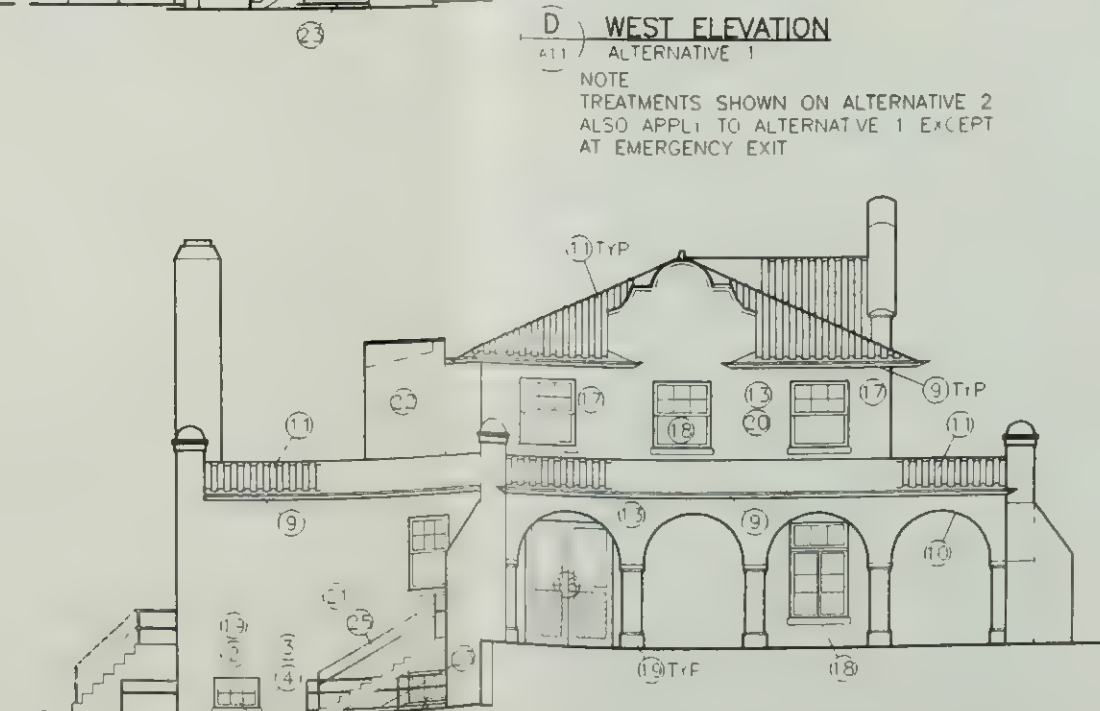
E WEST ELEVATION
A11 ALTERNATIVE 2

REMOVAL
(1) REMOVE WEST ARCADE ADDITION

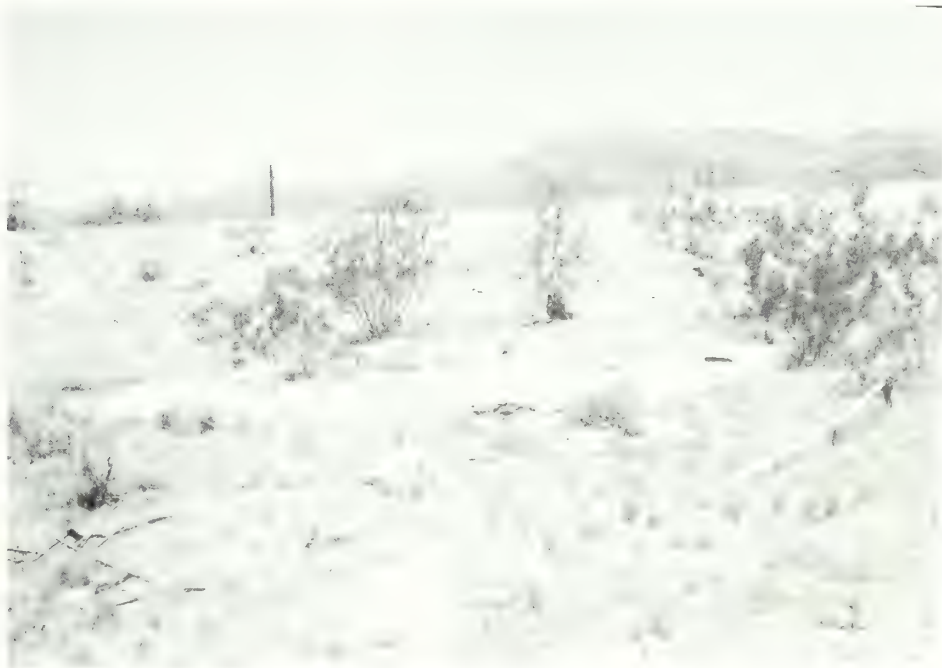
Figure 14: Feature 4, foundation, view to west, 1995.

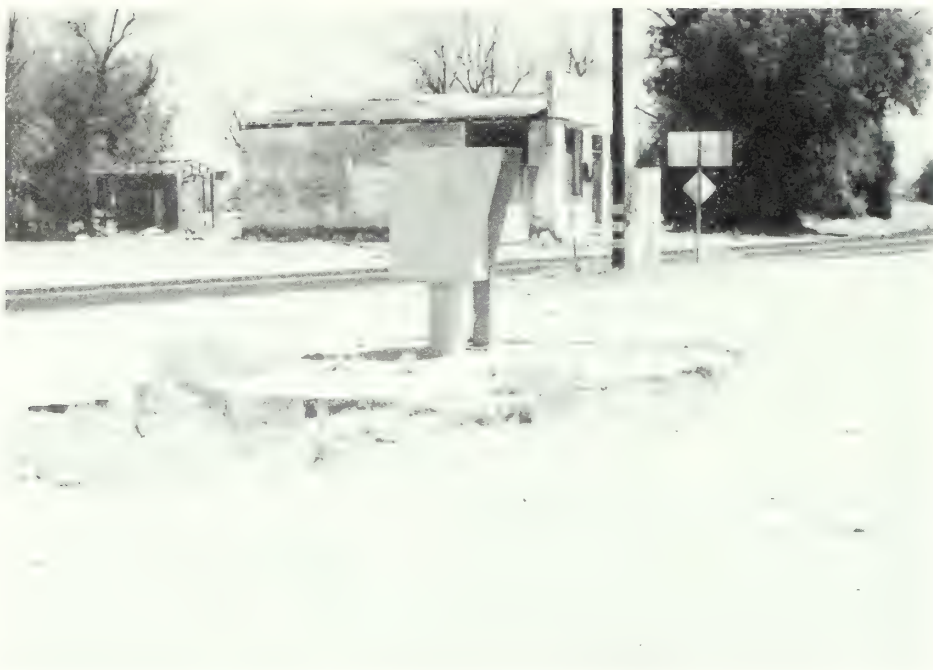
Figure 15: Feature 5, foundation, view to northeast, 1995.

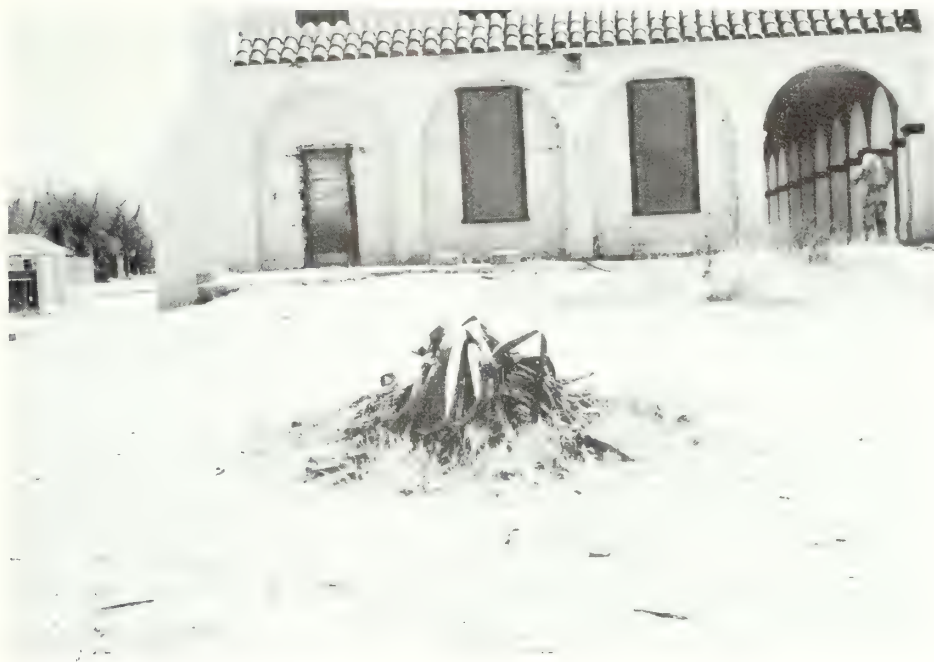
Figure 17: Features 14 and 17 (fire escape footings), and 20, (remains of century plant), 1995.

the east end of the depot. It is a concrete footing measuring 30 inches by 18 inches and has two rebar mounts in its top for anchoring the bottom of the fire escape (Figure 16). Feature 14a is located 9 feet north of the concrete slab on the west end of the depot. It is a concrete slab measuring 4 feet by 4 feet and has a step measuring 4 feet long, 18 inches wide, and 10 inches high with two rebar mounts in its top for anchoring the bottom of the fire escape. Feature 14b is located at the north end of the concrete slab at the west end of the depot. It is a concrete footing measuring 4 feet long, 1 foot wide, and 10 inches high, and was the foundation of the supports at the middle of the fire escape. Feature 17 is located 3 feet west of the depot on the concrete slab at the west end of the depot. Feature 17 consists of two square concrete footings (Figure 17). The footings measure 18 inches on a side and each has a rebar mount in its top. Feature 17 was the foundation for the supports for the upper end of the fire escape. Features 7, 14a and b, and 17 post-date the period of significance (Parks and Snyder 1991) and are not contributing elements to the National Register status of the property (Table 1).

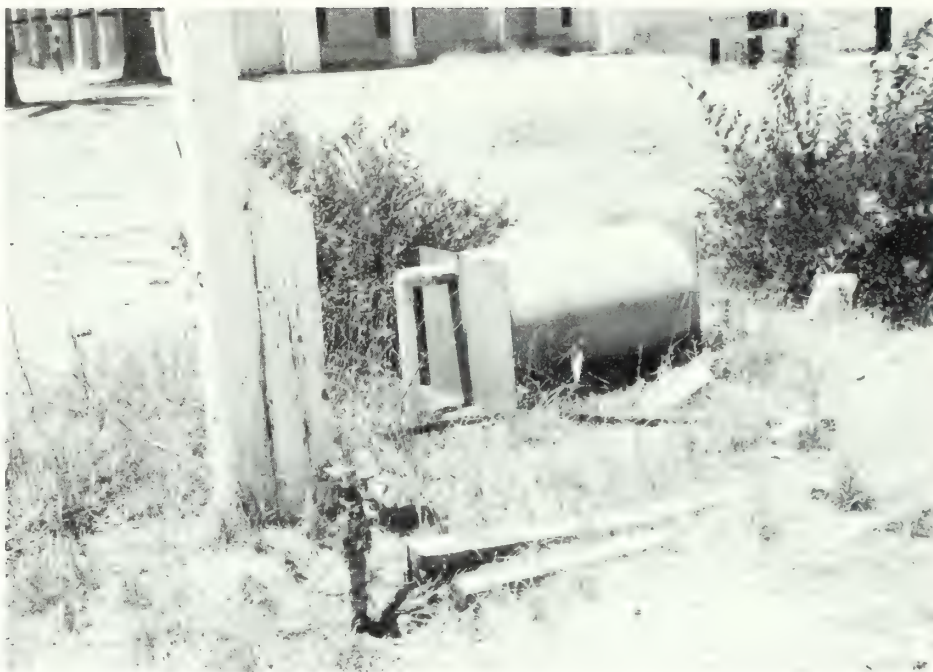
Figure 19: Feature 9 and south end of Feature 8, 1995.

Feature 9 consists of a water pump and spigot (Figure 19), which probably delivered water for the trains. It is located approximately 115 feet southeast of the depot and 25 feet north of the railroad tracks at the south end of Feature 8. Feature 9 appears to be contemporary and is not of historical significance.

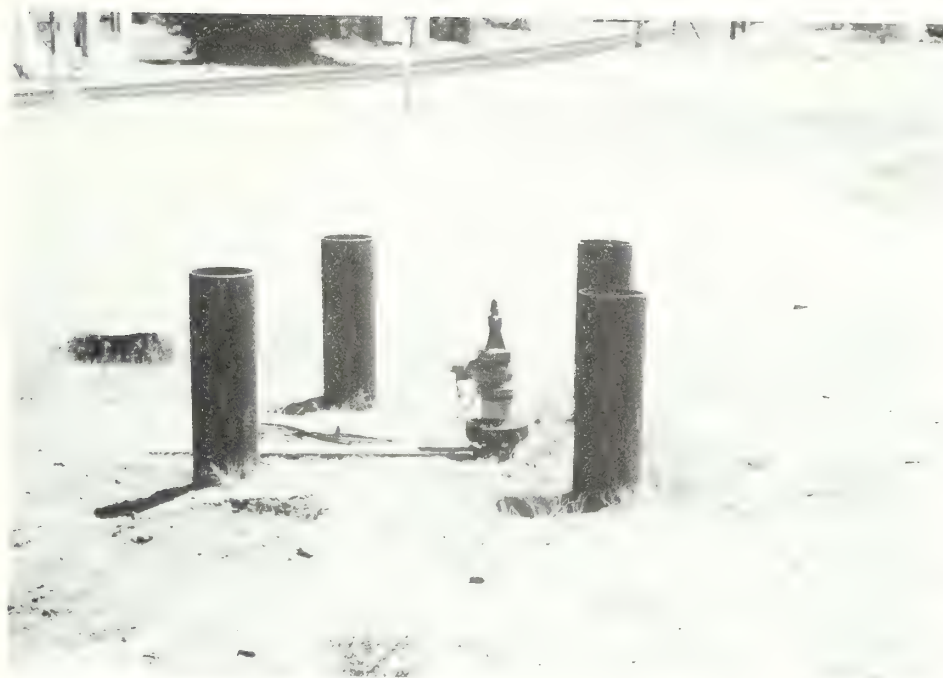
Figure 25: Feature 6 (fire hydrant), 1995.

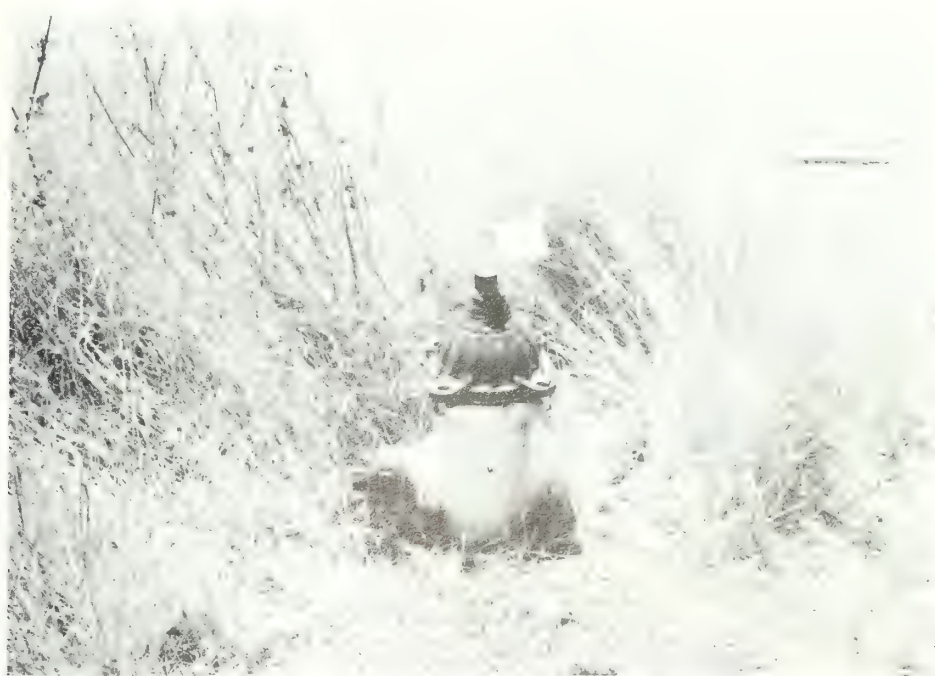
Figure 26: Feature 15 (fire hydrant), 1995.

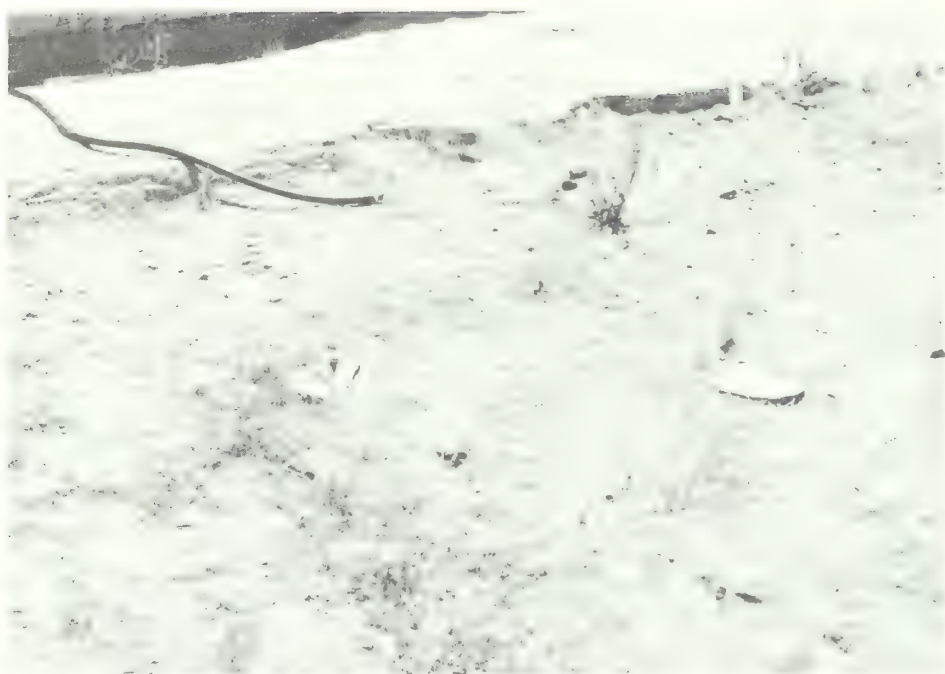
Figure 30: Feature 20 (base of lighted post), 1995.

Feature 20 is the base of a probable sign pole. It consists of a metal cone on a concrete footing (Figure 30). The footing is 16 inches in diameter and flush with the ground surface. The metal cone sits on top of the footing and is 11 inches high. It has a rectangular hole in its side with wires sticking out. Parks and Snyder (1991) indicate that there was a lighted signpost that bore a sign reading "KELSO" at the west end of the lawn. Feature 20 is located 45 feet west of the depot and could be the base for that sign.

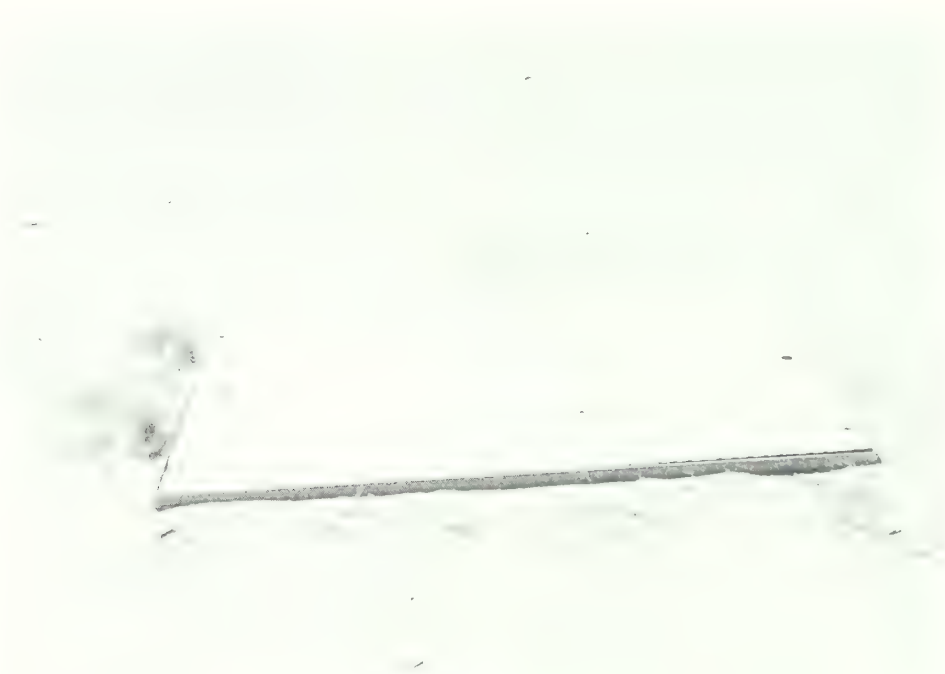
Figure 31: Features 21 (vertically buried metal pipe), and 22 (partially buried metal pipe).

Feature 21 consists of a 7-inch diameter metal pipe sticking vertically out of the ground located 35 feet west of the depot (Figure 31). The pipe has been capped with a rough-cut metal disk measuring 7.5 inches by 8.5 inches.

Feature 22 is a small diameter metal pipe laying horizontally on the ground (Figure 31). The west end is 15 feet west of the depot, and it extends eastward under the concrete slab at the west end of the depot.

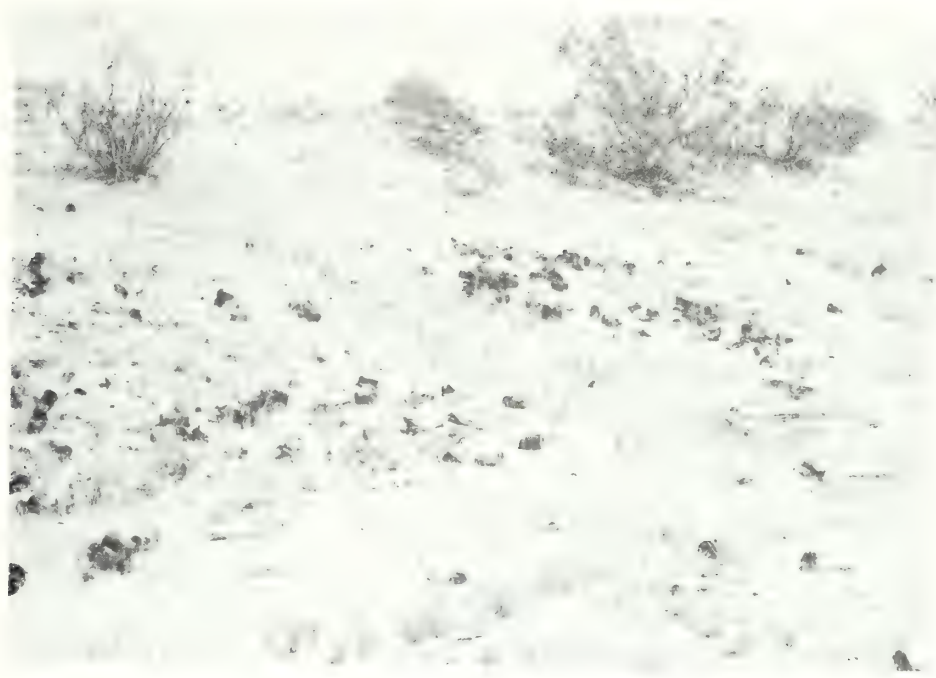
Figure 32: Feature 28 (buried metal box), 1995.

Feature 28 is a buried metal box (Figure 32). The top of the box is flush with the ground surface and is painted silver. It is located 100 feet east of the depot and 15 feet south of the Cima Road. The top of the box measures 52 inches by 45 inches and has "EDISON" embossed on it.

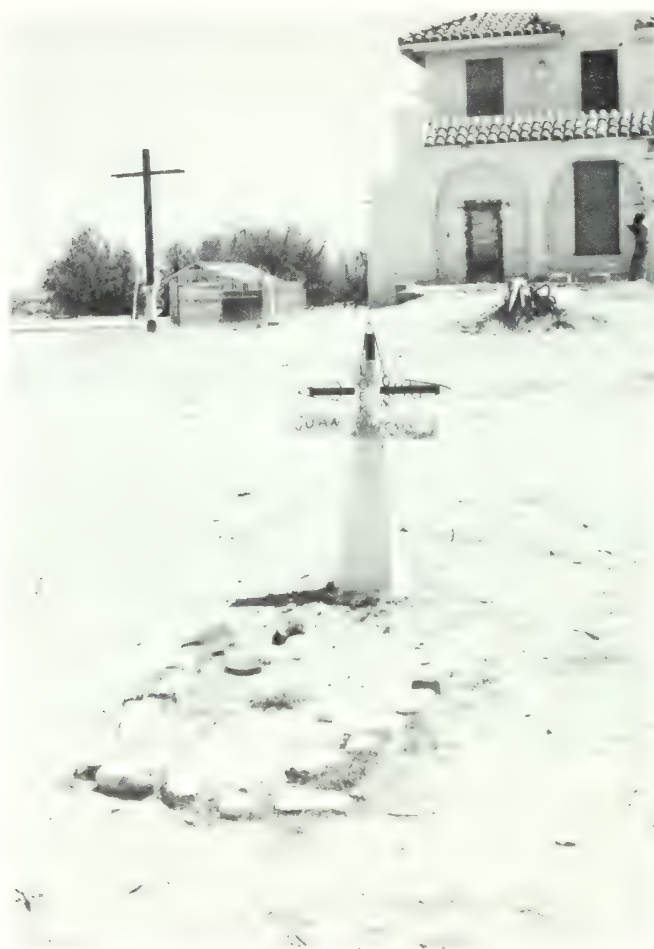
Figure 35: Feature 3 (cinder scatter), 1995.

Feature 3 consists of a scatter of cinders (Figure 35). The densest concentration covers an area of approximately 4500 square feet located from 60 feet to 200 feet east of Kelbaker Road and between the base of the levee and Cima Road. A thin scatter of cinders covers the area from the Kelbaker Road east to Feature 2. A department of Transportation work crew that stopped at the depot while field work was in progress, indicated that the area where Feature 3 is located is used by the county as a cinder staging area for road maintenance activities.

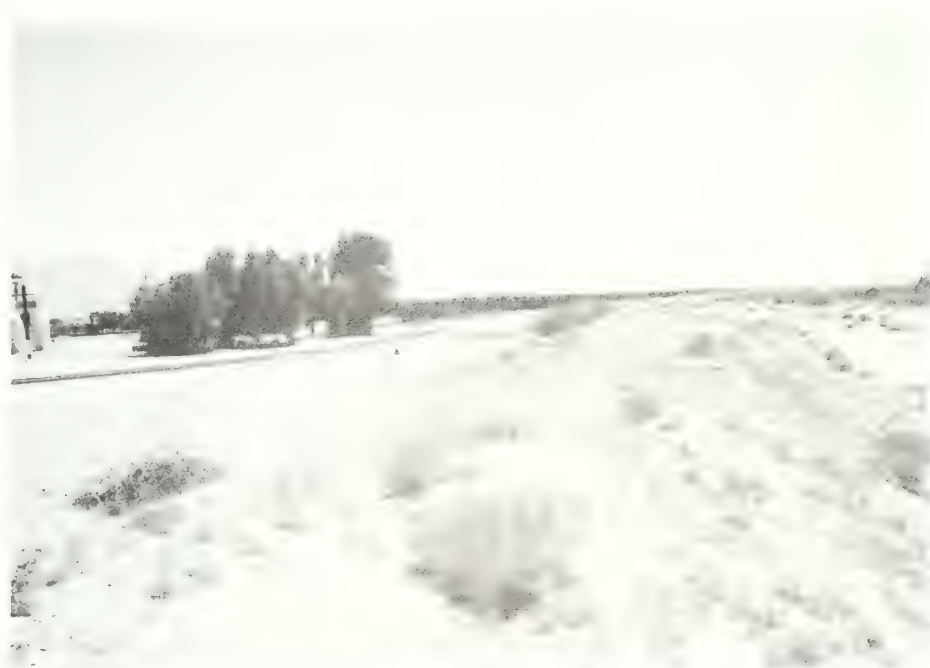
Figure 38: Feature 35 (levee), view to west, 1995.

Feature 35, a levee, runs east-west and is located 200 feet north of the depot. It runs for 0.6 miles east of the depot and an undetermined distance west of the depot (Figure 38). It crosses the northwest corner of the NPS property, and is approximately 7 feet high and from 30 to 50 feet wide. The levee separates the town of Kelso and the Union Pacific Railroad tracks from the natural drainage system in Kelso Wash located west of the levee. The levee does not appear in an early photo of the depot (Figure 4), but it is on the Kelso, California, 7.5', USGS quadrangle map dated 1983 (Figure 1).
